REPAIR, EVALUATION, MAINTENANCE, AND
REHABILITATION RESEARCH PROGRAM

TECHNICAL REPORT REMR-CO-1

STABILITY OF RUBBLE-MOUND BREAKWATER AND JETTY TOES; SURVEY OF FIELD EXPERIENCE

Dennis G. Markle

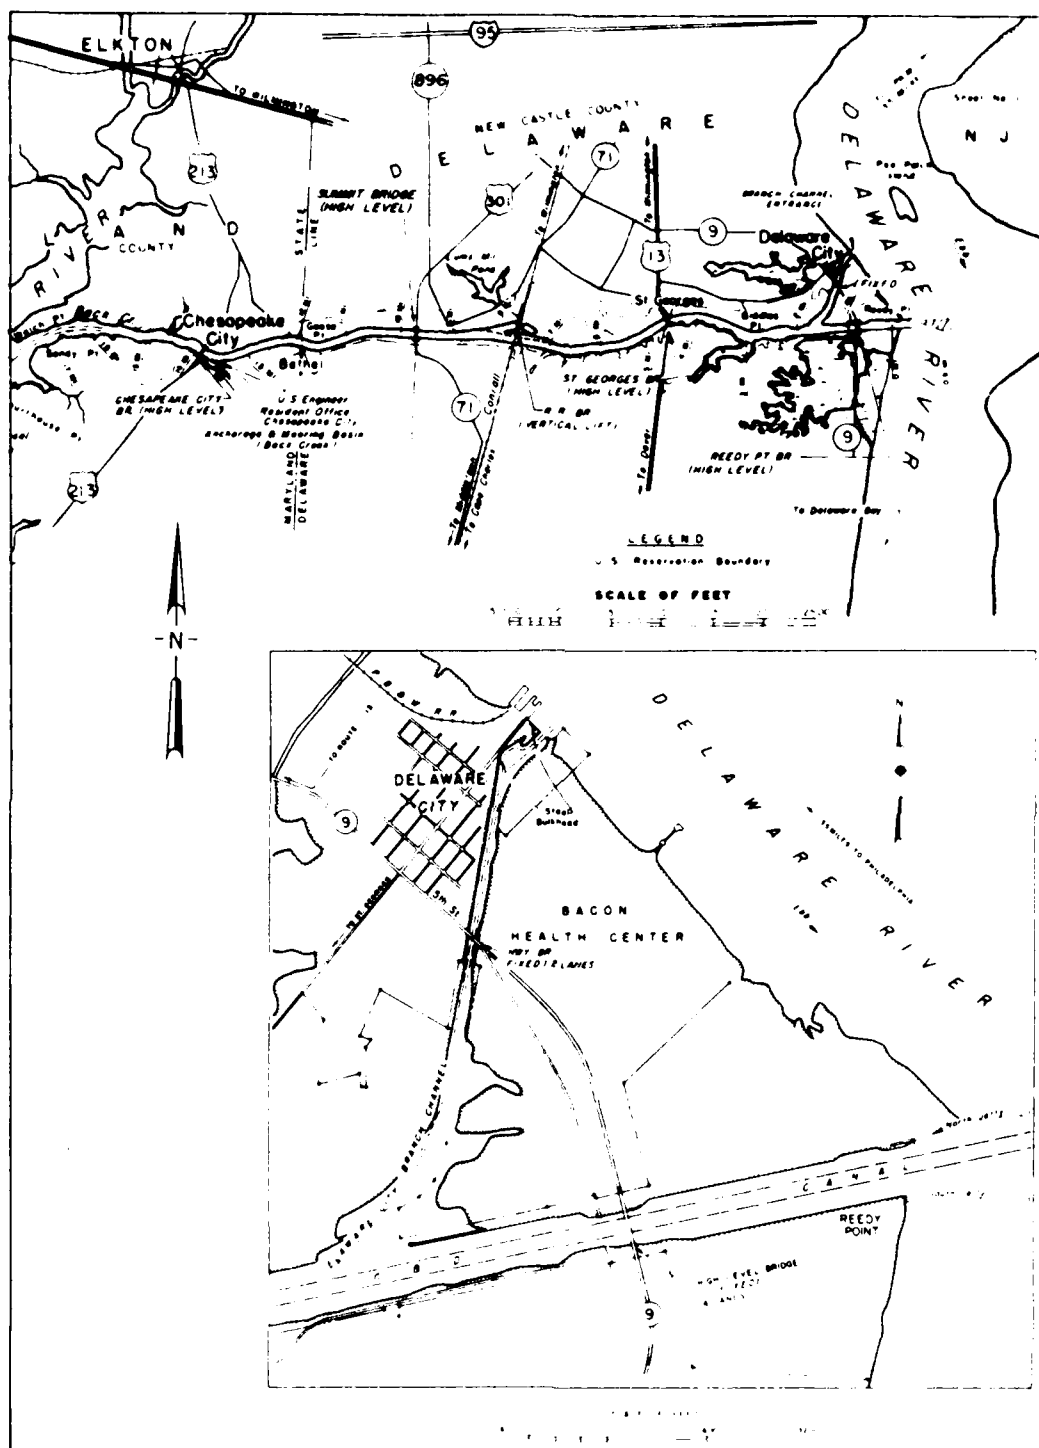
Figure 28. Reedy Point Jetties, Delaware

26. The jetties located at Reedy Point, where the Chesapeake and Delaware Bay Canal intersects the Delaware River, were originally constructed prior to 1938 (Figure 28). Both structures were of rubble-mound construction. In the 1960's the existing south jetty was removed, and a new south jetty was constructed farther south. This was done to increase the entrance size to accommodate larger vessels and improve navigation safety. The present jetties are both 2,095 ft long, and it was reported that the north jetty has problems with toe scour, loss of armor stone, and overall subsidence.

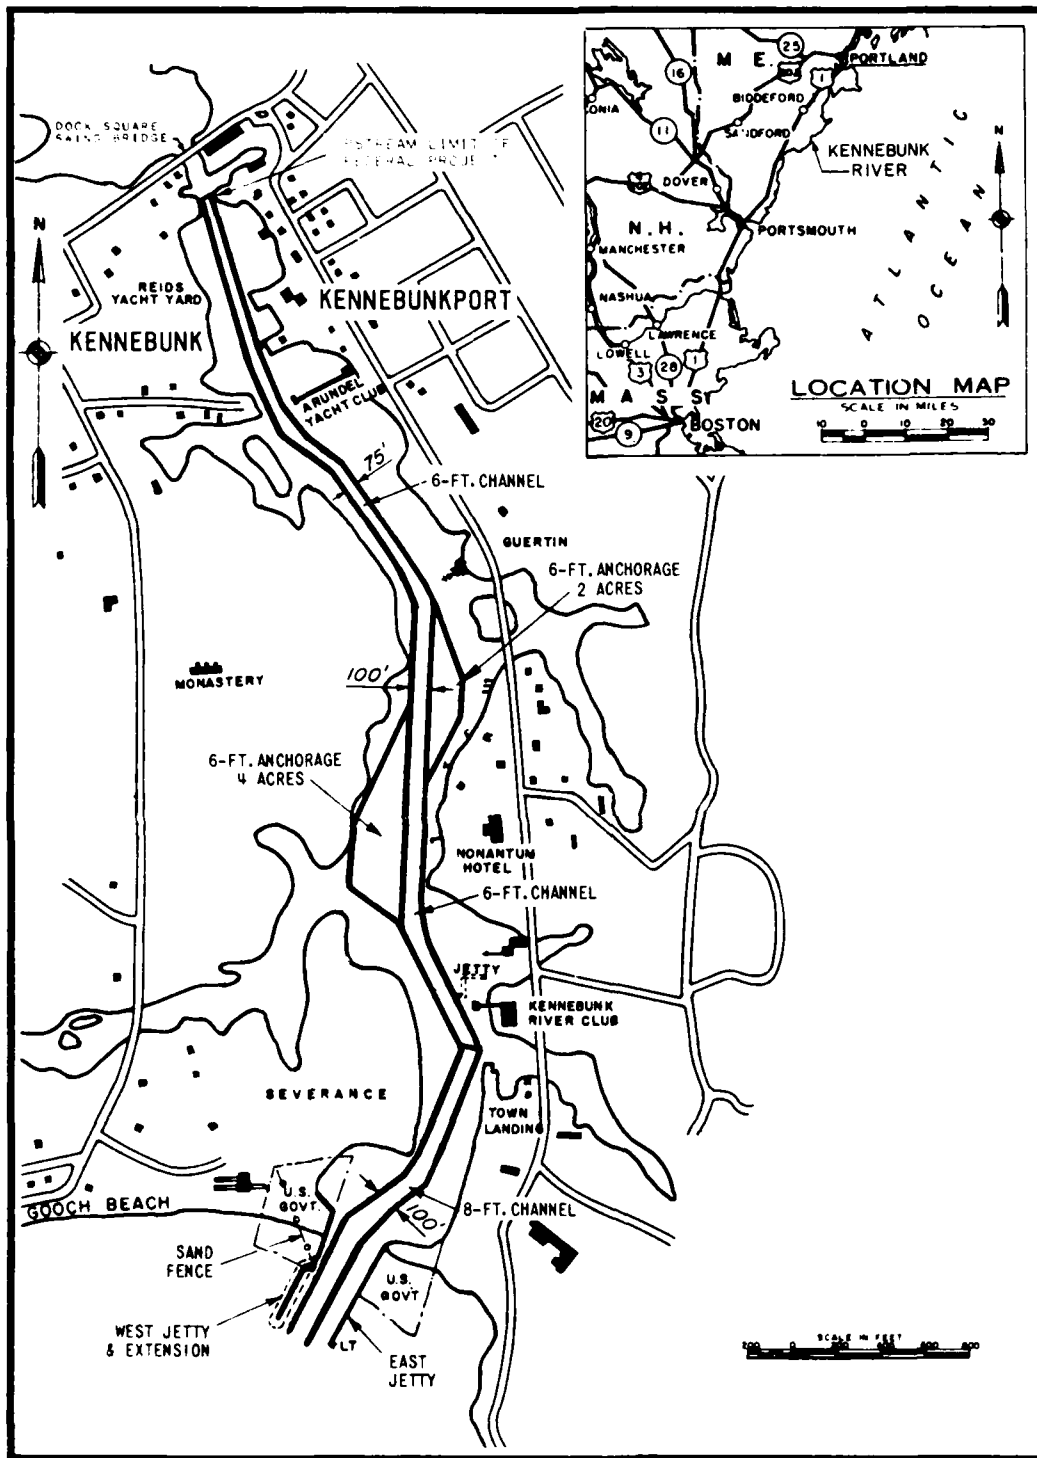
Figure 30. Kennebunk River Jetties, Maine

28. Based on review of historical repair data, it appears that three project sites within the New England Division that contain rubble-mound jetty structures have exhibited stability problems which could be related to instability of the structure toes. Both jetties at the mouth of the Kennebunk River, Maine (Figure 30), have a history of extension and repair. The latest jetty rehabilitation work was completed in 1982. Recent inspections show that both jetty heads are damaged and that 250 ft of the channel side of the east jetty have been undermined. The most recent inspection reports (1973-74), indicate that the north and south jetties at Newburyport Harbor, Massachusetts

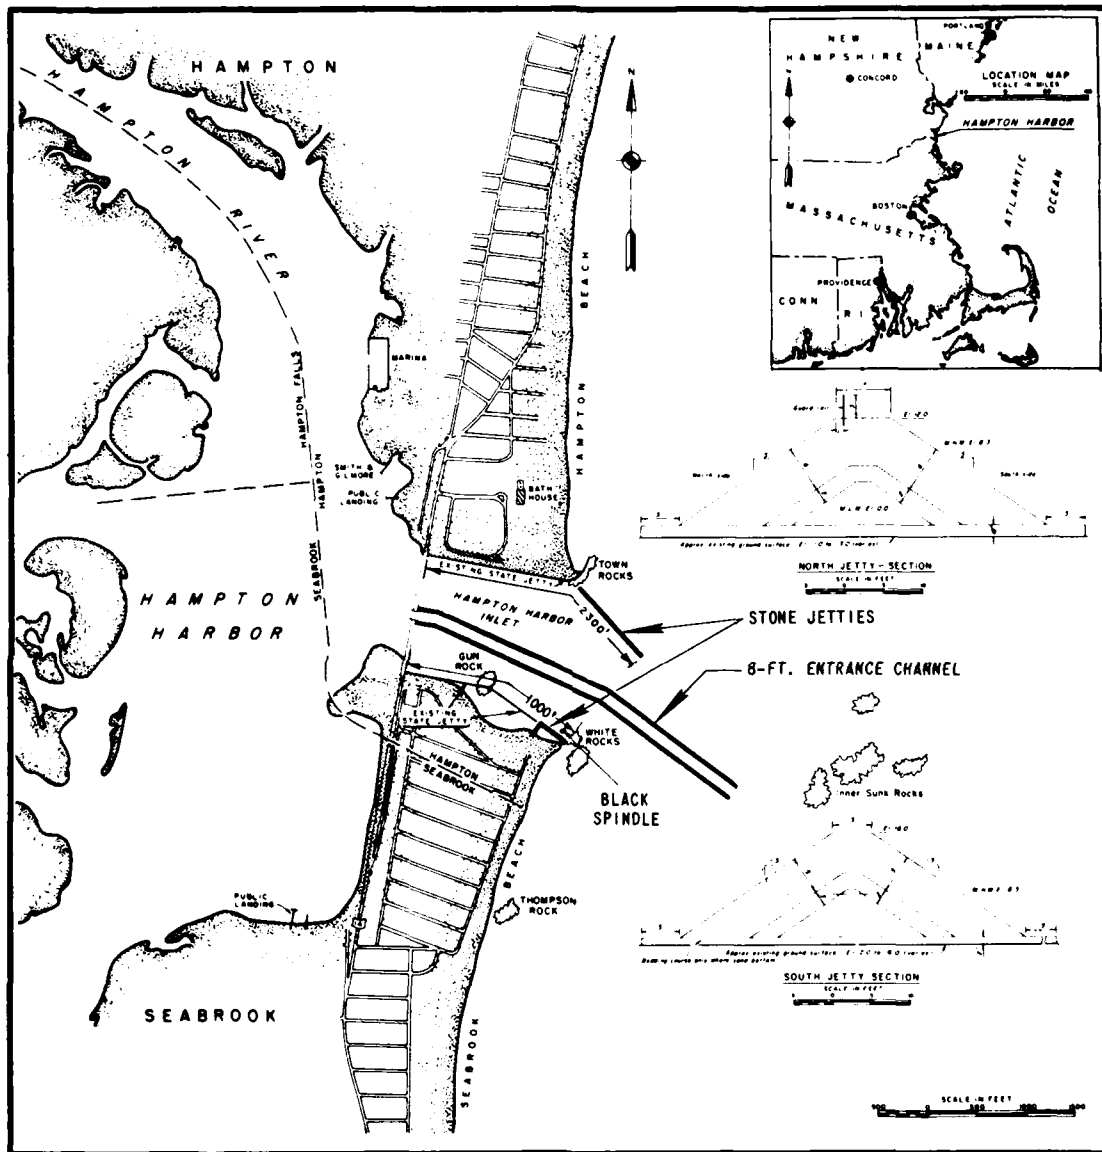
Figure 32. Hampton Harbor Jetties, New Hampshire

(Figure 31), which have an extensive repair and rehabilitation history, are showing considerable damage. This damage appears to result primarily from subsidence. Damage on four areas on the channel side of the south jetty most likely result from undermining of the rubble toe. The jetties at Hampton Harbor, New Hampshire (Figure 32), were originally constructed by the State and were turned over to the Corps in 1964. During 1965 to 1966, considerable work was done on both jetties. Since that time the south jetty has remained in good condition, while the north jetty has required continuous maintenance. Most of the repair and rehabilitation work has been needed on the seaward portions of the north jetty. The last rebuilding of the north jetty was completed in 1980, and it is thought that part of this recurring damage can be attributed to scour and undermining of the jetty toe.

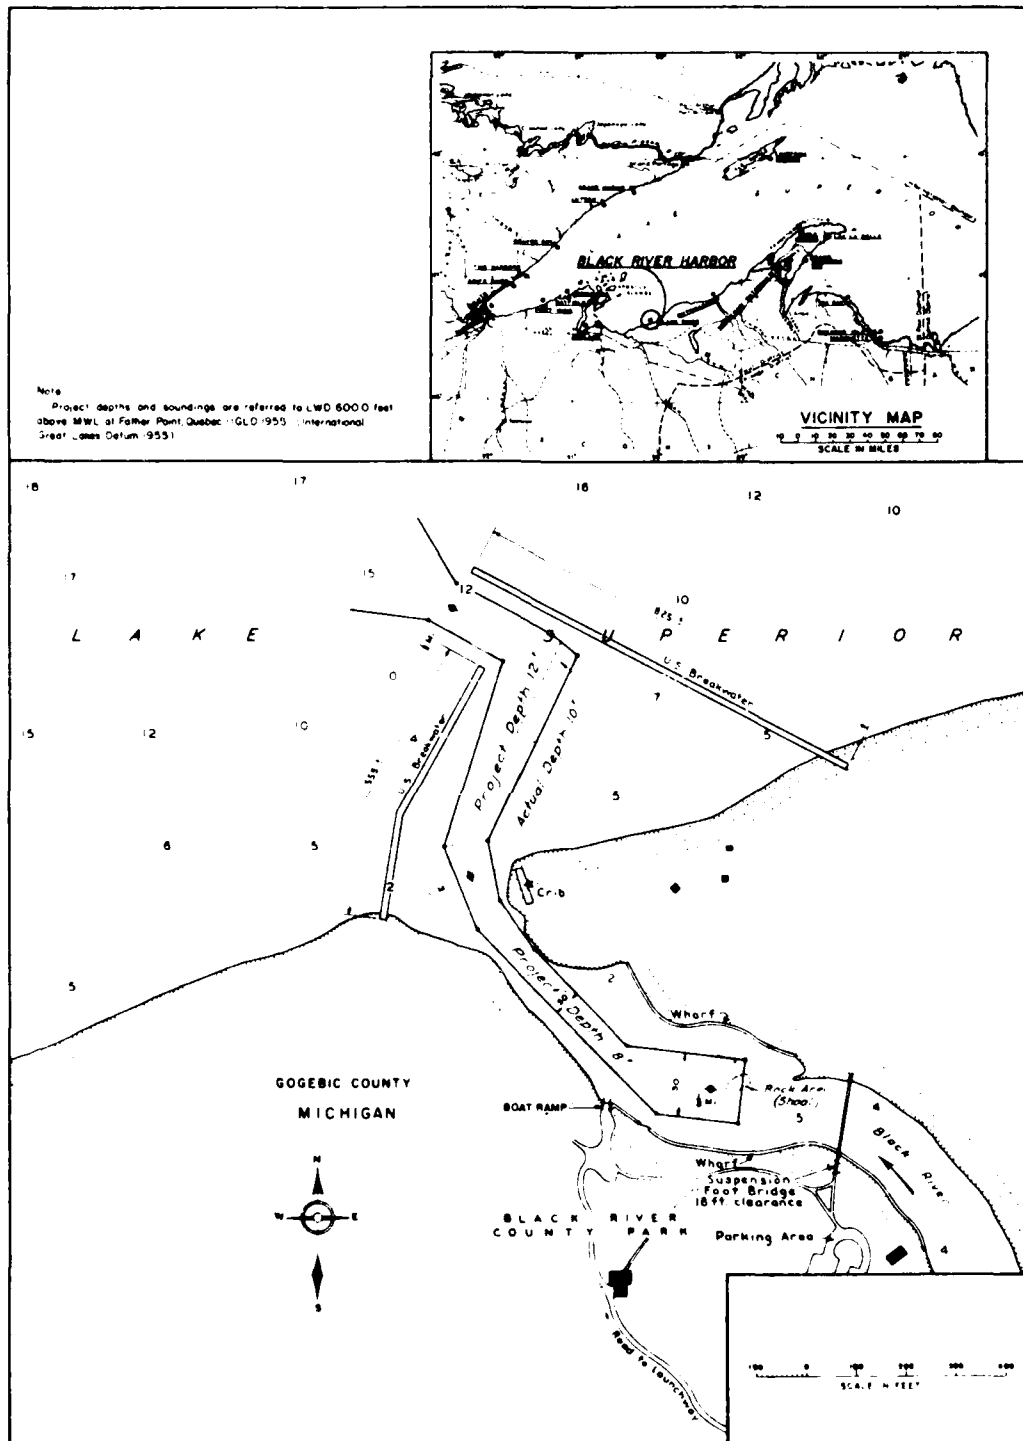
Figure 33. Black River Harbor Breakwaters, Michigan

30. Structures at Black River Harbor, Cheboygan Harbor, Hammond Bay Harbor, Harrisville Harbor, New Buffalo Harbor, and Point Lookout Harbor, Michigan, are purely rubble-mound construction (Figures 33-40). Charlevoix Harbor, Michigan; Duluth-Superior Harbor, Minnesota and Wisconsin; and Leland Harbor, Muskegon Harbor, Pentwater Harbor, Port Washington Harbor, and Traverse City Harbor, Michigan (Figures 41-55), have structures that are composed of a combination of rubble mound, timber cribs, timber piles, steel sheet piles, concrete caissons, steel cells, concrete caps, and concrete superstructures. The head of the east jetty on the north end of the Keweenaw Waterway, Michigan (Figures 56 and 57), is an old timber crib which is encased in rubble. For this reason, its response is very similar to that of a purely
